**Support Action for Strengthening PAlestine  
capabilities for seismic Risk Mitigation  
SASPARM 2.0**

**Deliverable D.C.1**

**Report on the identification of retrofit measures**

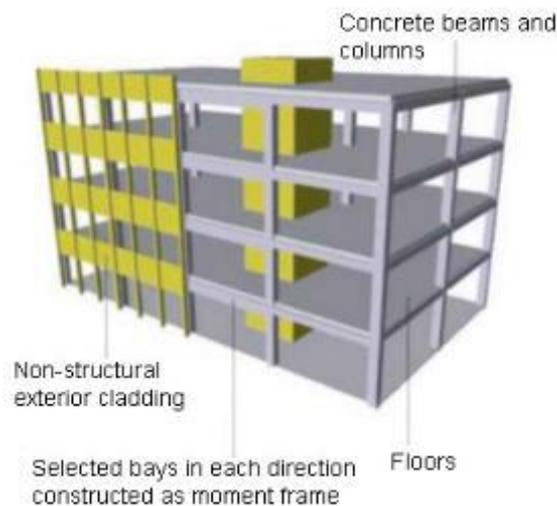
Type C1 can be generically defined as a complete system of beams and columns supporting slabs (Figure 2.1). Regarding slab, two typologies have been identified: solid with drop beams that account for 3% of the in-built and ribbed slab with hidden beams, that is the most common (95%). Just a few portion of building (2%) has no beams at all. Lateral forces are resisted by cast-in-place moment frames that develop stiffness through rigid connections of the column and beams. Moreover, the presence of strong infills for the allocation of elevator and staircases increases the overall stiffness of the system.

Figure 2.1. Reinforced concrete frame building (C1) [1].

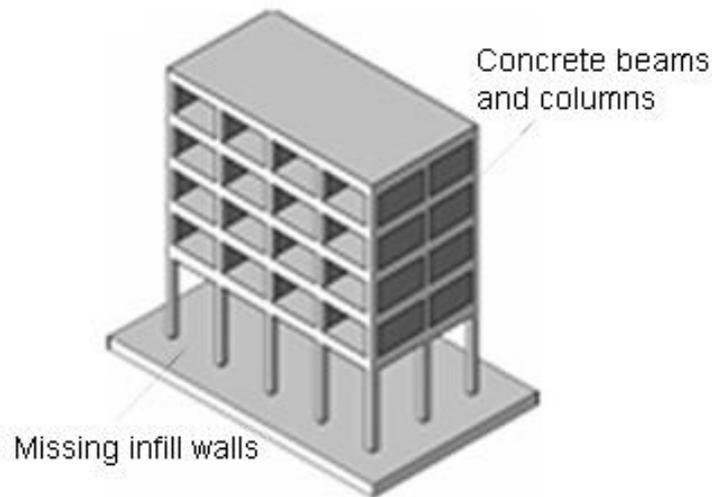
RC buildings with soft storey (C1a) can be defined as a subclass of C1. They have the same structural characteristics of a reinforced concrete frame building, but with the peculiarity of lacking significant infill walls in a floor or in a side of it (Figure 2.2).

Figure 2.2. RC building with soft storey (C1a).

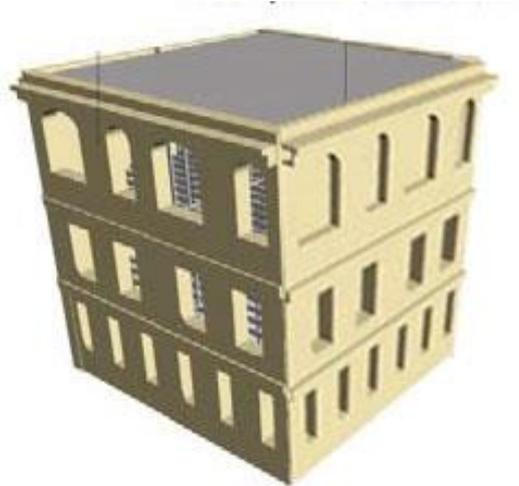
Finally, building Type URM (Figure 2.4) consists of unreinforced masonry bearing walls made up of stones in two layers with concrete in between or stones clades row-by-row with concrete casts behind them via formwork. In general, all walls act as both bearing and shear walls and the floors are concrete slabs cast-in-place.

Figure 2.4. Unreinforced masonry building (URM) [1].

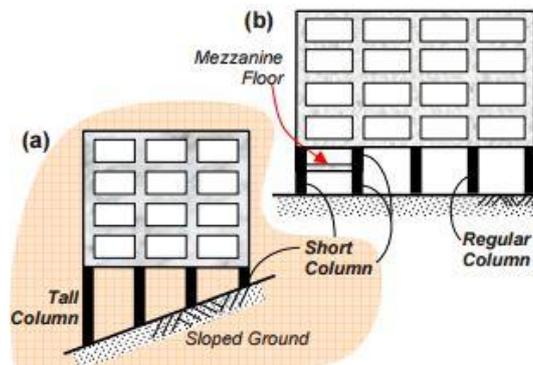
There is another special situation in buildings when short-column effect occurs. Consider a wall (masonry or concrete) of partial height built to fit a window over the remaining height. The adjacent columns behave as short columns due to presence of these walls. In many cases, other columns in the same storey are of regular height, as there are no walls adjoining them. When the floor slab moves horizontally during an earthquake, the upper ends of these columns undergo the same displacement (Figure 4.3). However, the stiff walls restrict horizontal movement of the lower portion of a short column, and it deforms by the full amount over the short height adjacent to the window opening. On the other hand, regular columns deform over the full height [4].

Figure 4.2. Buildings with short columns – two explicit examples of common occurrences.

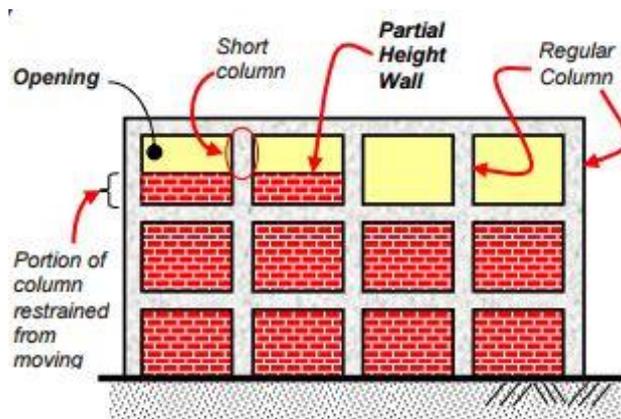
Since the effective height over which a short column can freely bend is small, it offers more resistance to horizontal motion and thereby attracts a larger force as compared to the regular column. As a result, short column sustains more damage. Figure 4.4 shows X-cracking in a column adjacent to the walls of partial height.

Figure 4.3. Short columns effect in RC buildings when partial height walls adjoin columns.

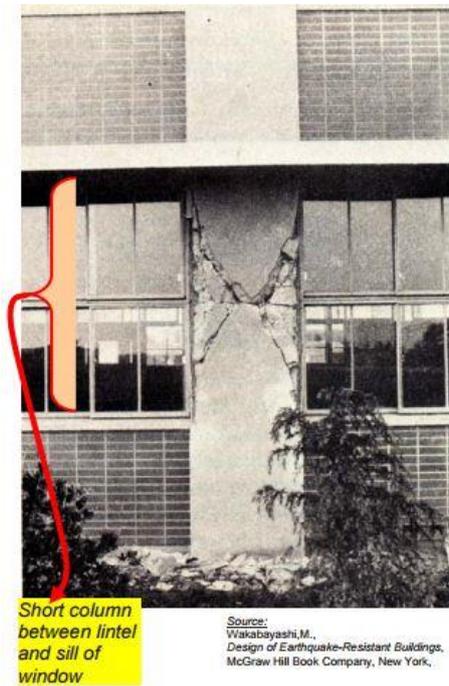
Poor behaviour of short columns is due to the fact that in an earthquake, a tall column and a short column of same cross-section move horizontally by same amount  $\Delta$  (Figure 4.5). However, the short column is stiffer as compared to the tall column, and it attracts larger earthquake force. Stiffness of a column means resistance to deformation – the larger is the stiffness, larger is the force required to deform it. If a short column is not adequately designed for such a large force, it can suffer significant damage during an earthquake. This behaviour is called Short Column Effect. The damage in these short columns is often in the form of X-shaped cracking – this type of damage of columns is due to shear failure. In new buildings, short column effect should be avoided to the extent possible during architectural design stage itself. When it is not possible to avoid short columns, this effect must be addressed in structural design. Several seismic codes for ductile detailing of RC structures require special confining reinforcement to be provided over the full height of columns that are likely to sustain short column effect.

Figure 4.4. Short column effect due to partially filled frame opening.

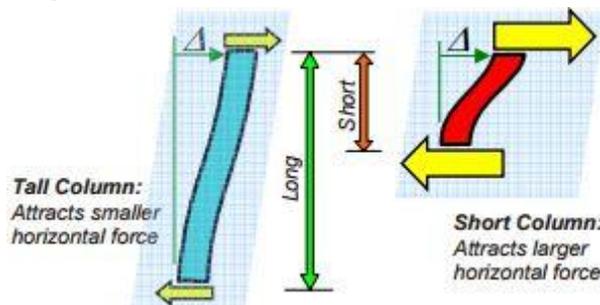
Figure 4.5. Cross-section horizontal seismic movement of columns.

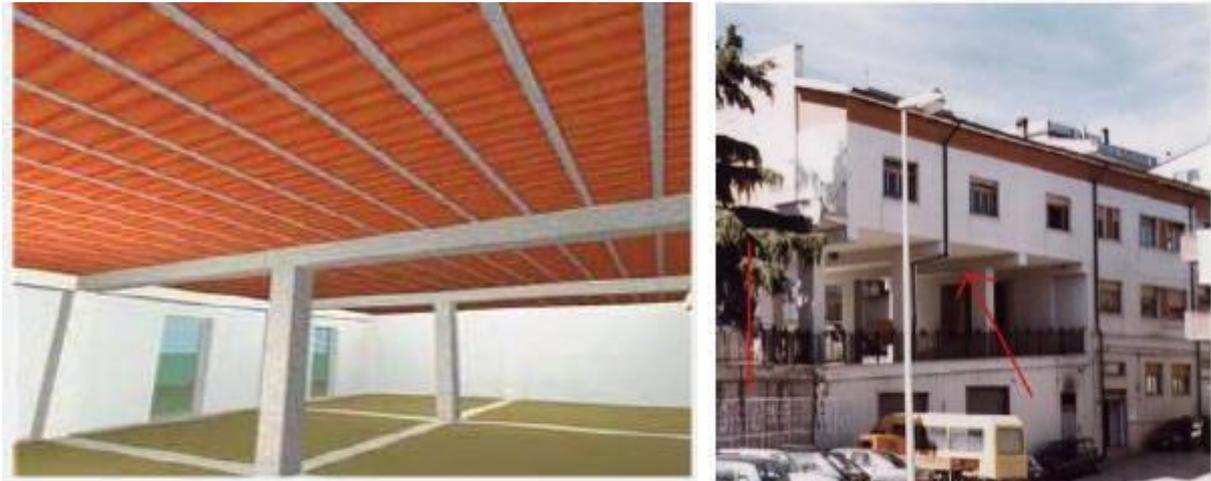
Figure 5.2. Frame irregularity example [6].

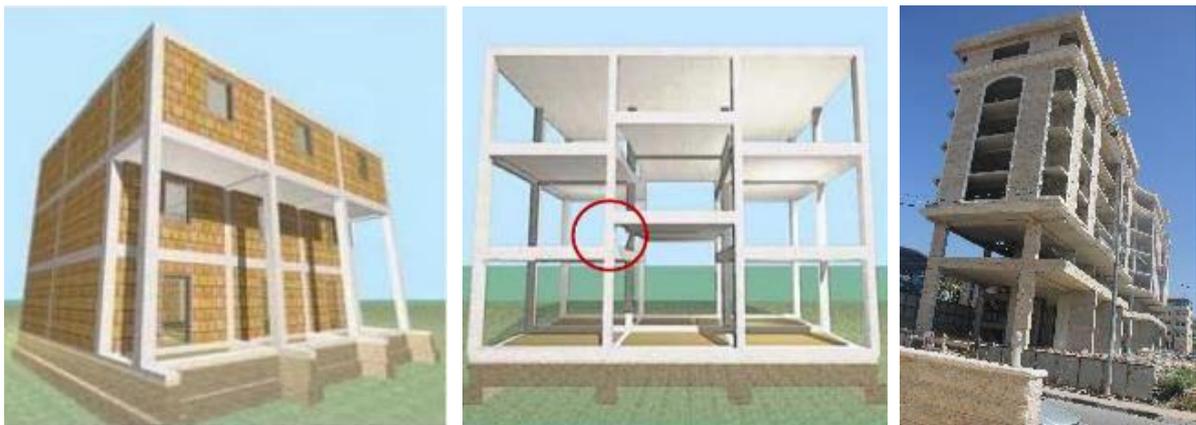
- Frames with inadequate stiffness: tall column with instability problem or short column with high concentration of shear stress (Cf. §4.2 for more details).

Figure 5.3. Tall column (left and centre) [6] and short column (right) examples.

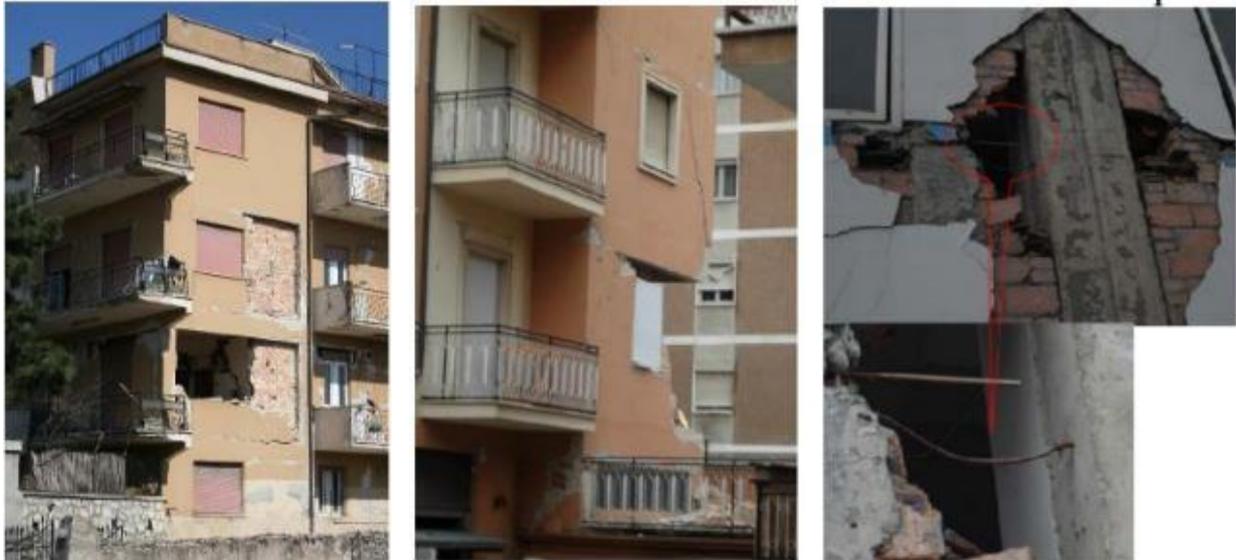
Infill walls on the RC frame structure with an inappropriate arrangement can cause asymmetrical behaviour. Due to the offset of the lateral rigidity centre of the floor (stiffness eccentricity in plan), the additional torsions cause the side and corner columns to be damaged easily under an earthquake.

Figure 5.4. Walls failing examples [6].

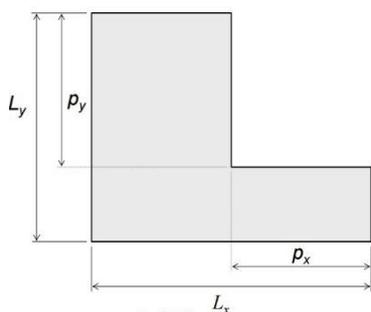
Re-entrant corner arises in case of plans in H, I, T, L, C, U shapes. Presence of re-entrant corners are one of the serious plan irregularities that results in poor seismic performance of buildings. There are two major problems associated with re-entrant corners. The first is the torsion caused by the centre of mass and the centre of rigidity not coinciding, and the second is that they tend to produce differential motion between different wings of the building leading to local stress concentration at the re-entrant corner.

Irregularity for re-entrant corners exists if  $p_x > 0.15 L_x$  and  $p_y > 0.15 L_y$  [11]

Figure 5.5. Irregularity for re-entrant corner.

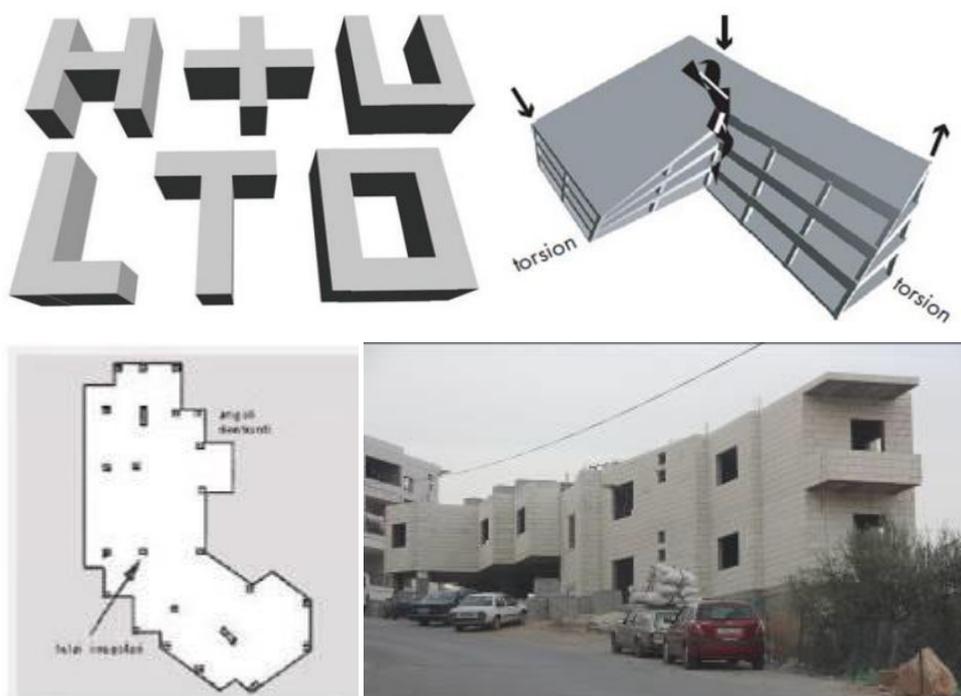
Figure 5.6. Examples of re-entrant corners [12] and Nablus building example (right-below).

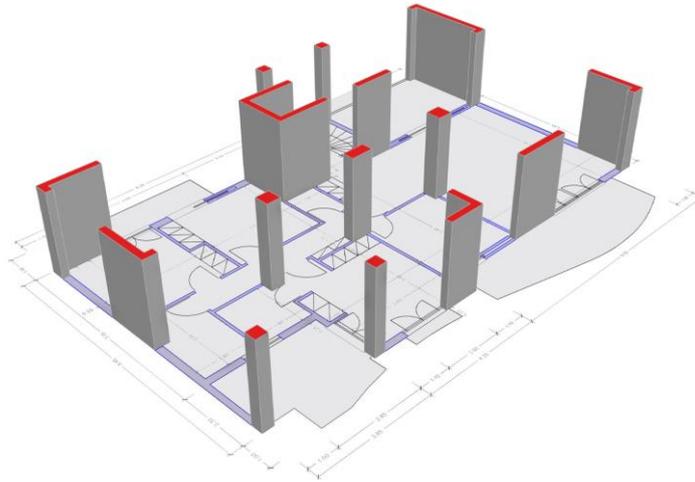
- Torsional layout (RC elevator core and staircase).

Figure 5.7. Torsional layout of RC shear wall elevator.

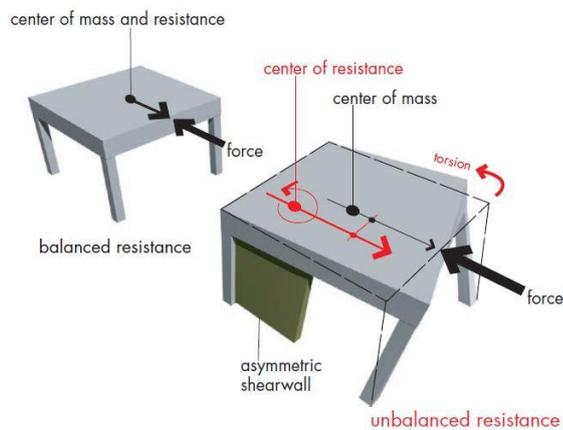
For this reason, it is recommended that buildings be designed as symmetrical as possible. In practice, some degree of torsion is always present, and the building code makes provision for this.

Figure 5.8. Balanced and unbalanced configurations [5].

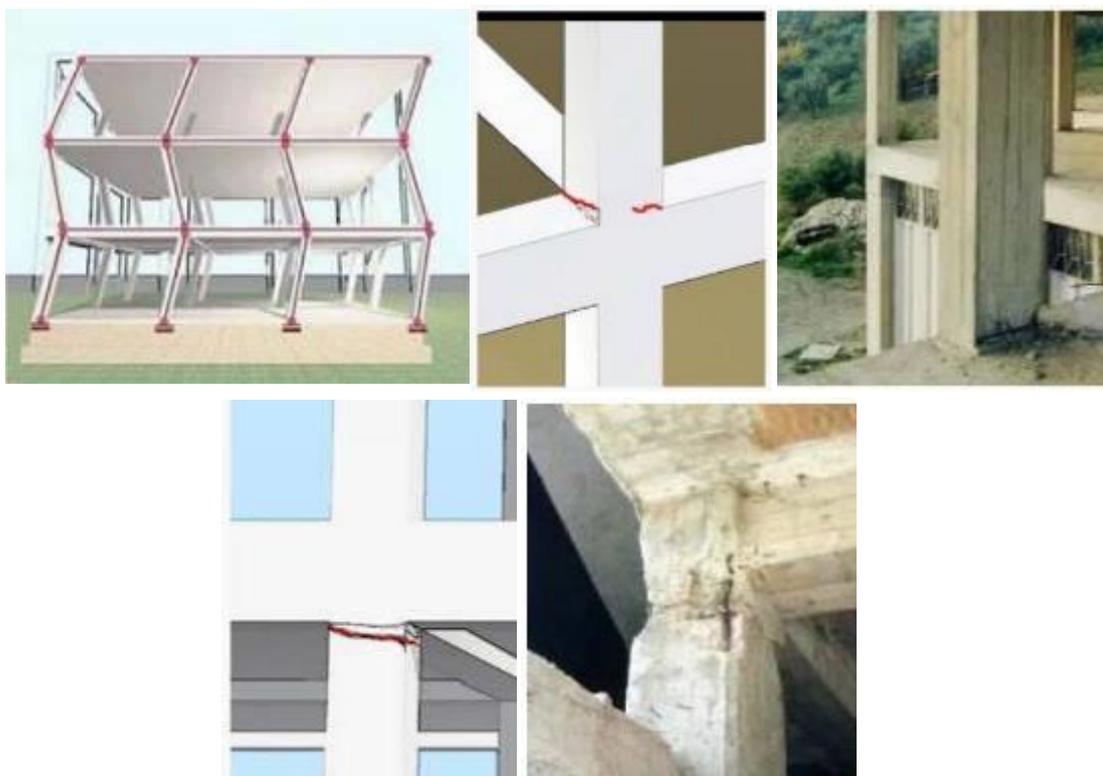
- Weak column – strong beam. Plastic hinge at the top or the base of the column due to an element with higher stiffness (Cf. § 4.1 for more details).

Figure 5.9. Weak column – strong beam examples [6].

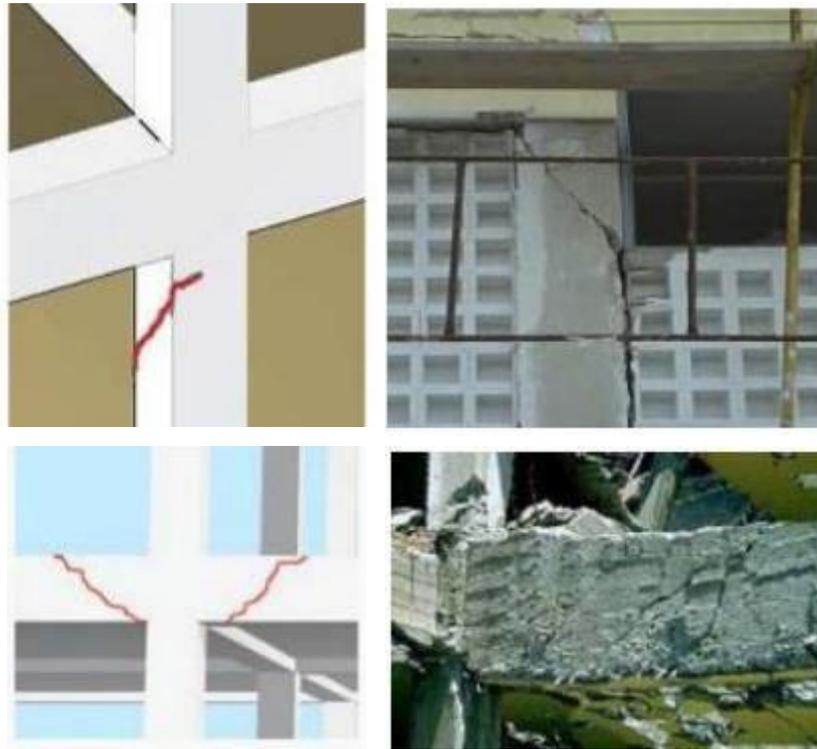
- Inadequate transverse reinforcement in beams and/or columns that provides the necessary shear resistance, confinement of concrete and restraint against buckling of longitudinal reinforcement.

Figure 5.10. Inadequate shear strength examples [6].

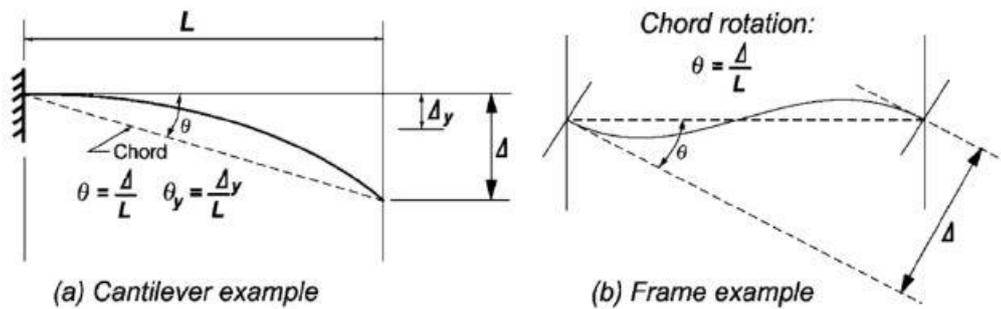
- Insufficient flexural capacity. Inadequate confinement of beams/columns/walls in the critical regions where the plastic hinges form does not allow the sections to reach large curvature values and therefore limits the chord rotation capacity (ductility) and energy dissipation of the elements.

Figure 5.11. Definition of chord rotation (rotation angle).

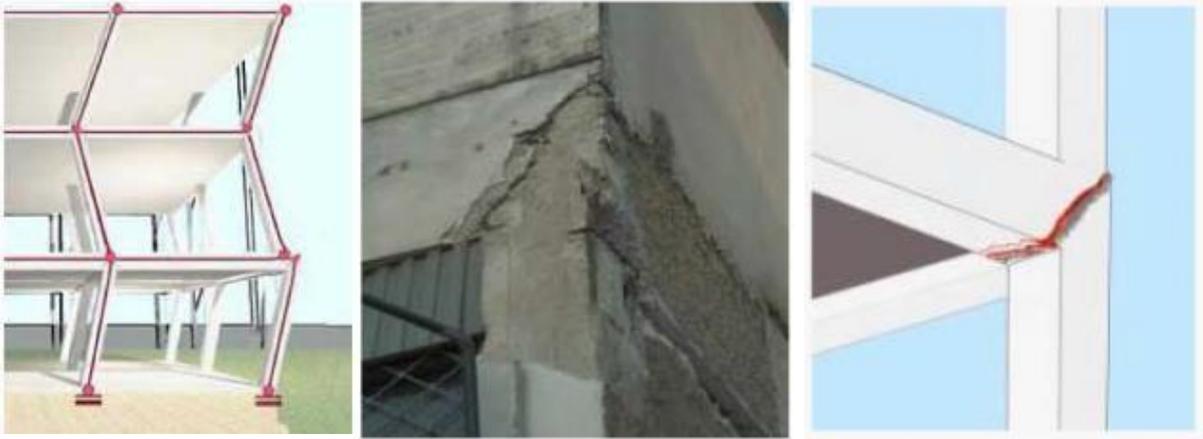
- Splices. This failure mechanism is related to beam-column joint that has an inadequate reinforcement and/or an improper anchorage of longitudinal beam reinforcement. For this reason, the splice becomes a weak zone.

Figure 5.12. Splice crack example [6].

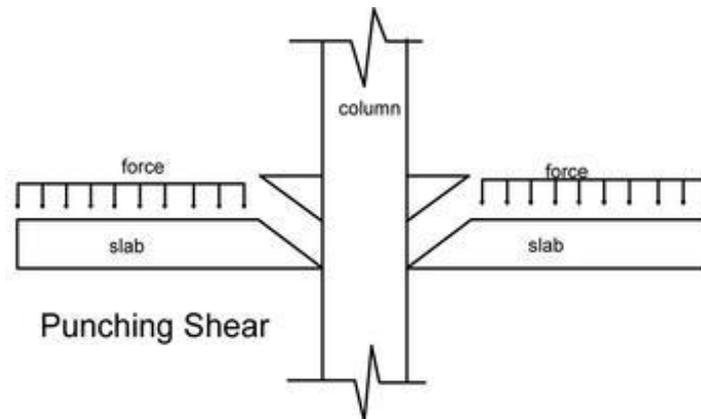
- Punching shear failure of slab-column connection. Punching shear is a type of failure of reinforced concrete slabs subjected to high localized forces. In flat slab structures this occurs at column support points. The failure is due to shear. This type of failure is catastrophic because no visible signs are shown prior to failure.

Figure 5.13. Punching shear failure of slab-column connection.

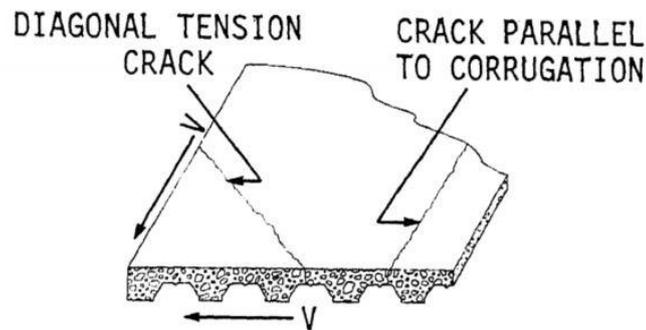
- Inadequate in-plane shear capacity. When the concrete stress reaches its tensile limit, diagonal cracks (at an angle of approximately  $45^\circ$ ) occur across the slab. Another type of diaphragm failure is a direct shearing of the concrete along a line parallel to the deck corrugations. If the concrete covering is thin, this failure will be most likely to occur, with the ultimate shear strength depending on the shear strength of the concrete.

Figure 5.14. Crack examples in slab.

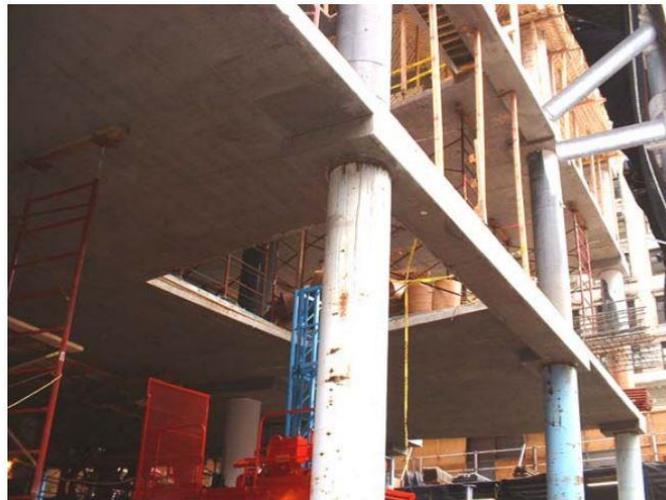
- Excessive stresses at openings and irregularities. For new structures, openings in the slab are usually determined in the early stages of design. On the other side, for existing structures analysis and strengthening methods are typically required for accounting new openings. Cutting openings in existing slabs should be approached with caution and avoided if possible. When cutting an opening in an existing slab, the effect on the structural integrity of the slab must be analysed. It is advisable to analyse the slab for excess capacity and possible moment redistribution before making the final decision on the sizes and locations of the openings [7].

Figure 5.15. Excessive opening example [7].

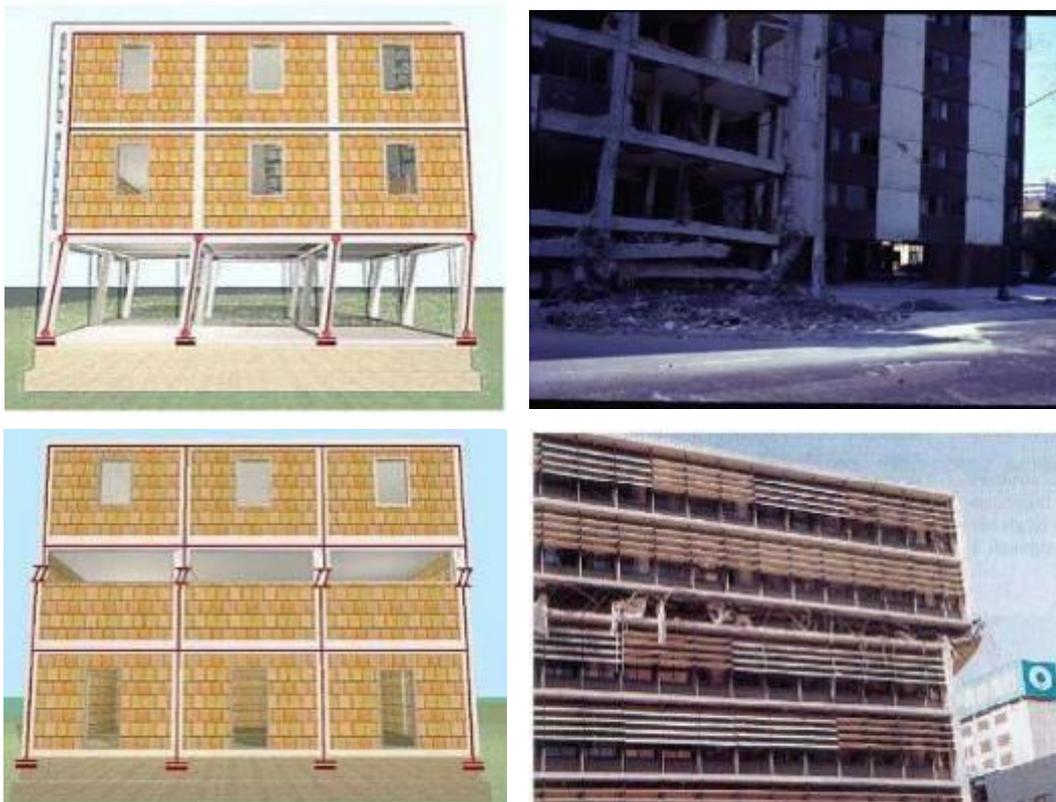
Building with shopping stores with large glass window openings at the ground floors also fall into this category. Besides, discontinuity in infill walls and variation in their location along the elevation also provides the ground for the development of soft storey. In such cases, an intermediate storey could also serve as soft storey if its stiffness is considerably lower than adjacent storeys.

Figure 6.2. Soft story examples [6].

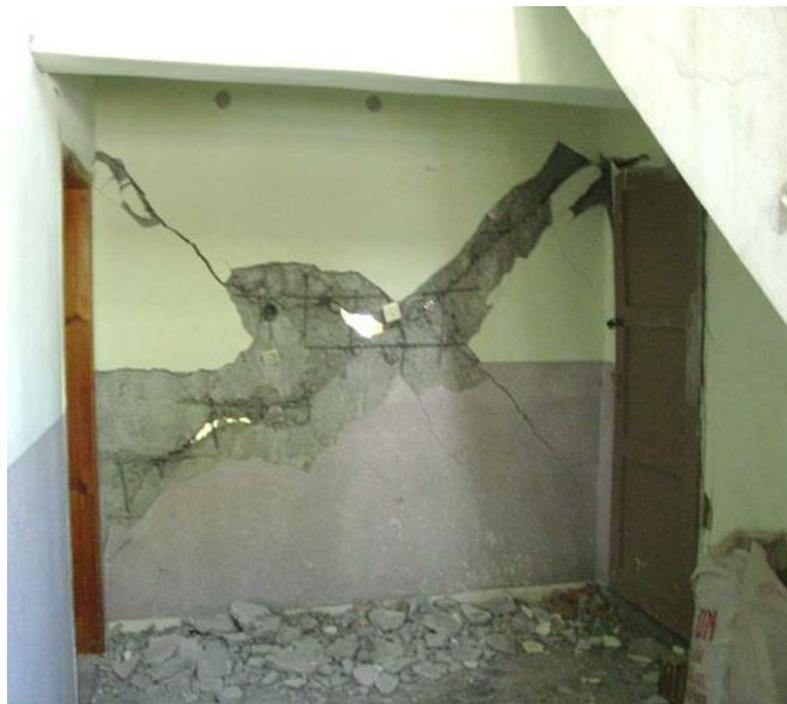
Figure 7.2. Shear failure of RC wall.

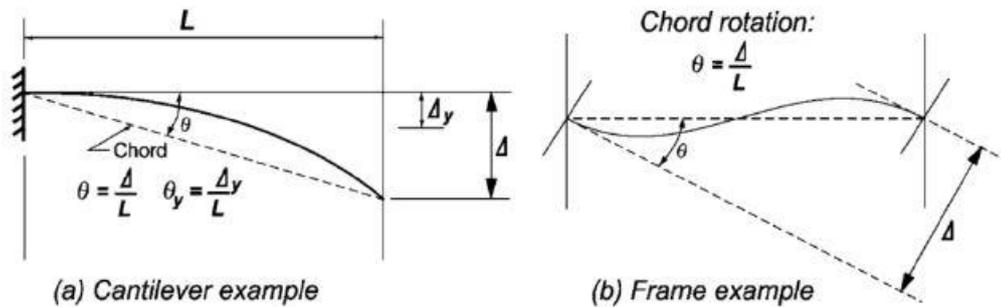
- Insufficient flexural capacity. Inadequate confinement of beams/columns/walls in the critical regions where the plastic hinges form does not allow the sections to reach large curvature values and therefore limits the chord rotation capacity (ductility) and energy dissipation of the elements.

Figure 7.4. Definition of chord rotation (rotation angle).

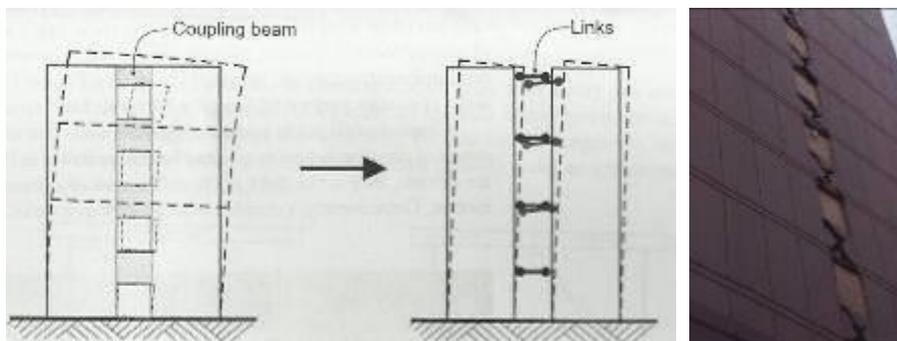
- Brittle failure of coupling beams. Coupled shear walls consist of two shear walls connected intermittently by beams along the height. The behaviour of coupled shear walls is mainly governed by the coupling beams. The primary purpose of beams between coupled walls during earthquake actions is the transfer of shear from one wall to the other. In considering the behaviour of coupling beams it should be appreciated that during an earthquake significantly larger inelastic excursions can occur in such beams than in the walls that are coupled. During one earthquake, larger numbers of shear reversals can be expected in the beams than in the walls. Many coupling beams have been designed as conventional flexural members with stirrups and with some shear resistance allocated to the concrete. Such beams will inevitably fail in diagonal tension. It is evident that the principal diagonal failure crack will divide a relatively short beam into two triangular parts. Unless the shear force associated with flexural overstrength of the beam at the wall faces can be transmitted by vertical stirrups only, diagonal tension failure will result [8].

Figure 7.5. Shear failure of coupling beams.

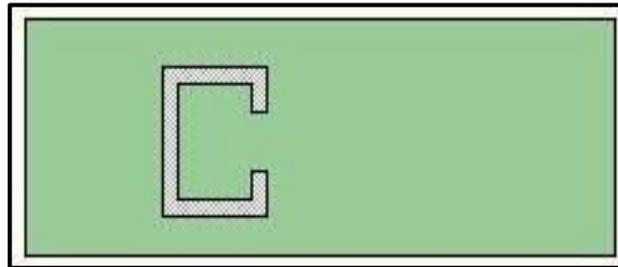
If the core remains in a position leading to torsional behavior as in Figure 7.6, then it must be designed explicitly for torsion (strong coupling beams). It is far preferable to adopt a symmetrical arrangement to avoid this. (Cf. §5 – Torsional layout for more details).

Figure 7.6. Torsional layout configuration.

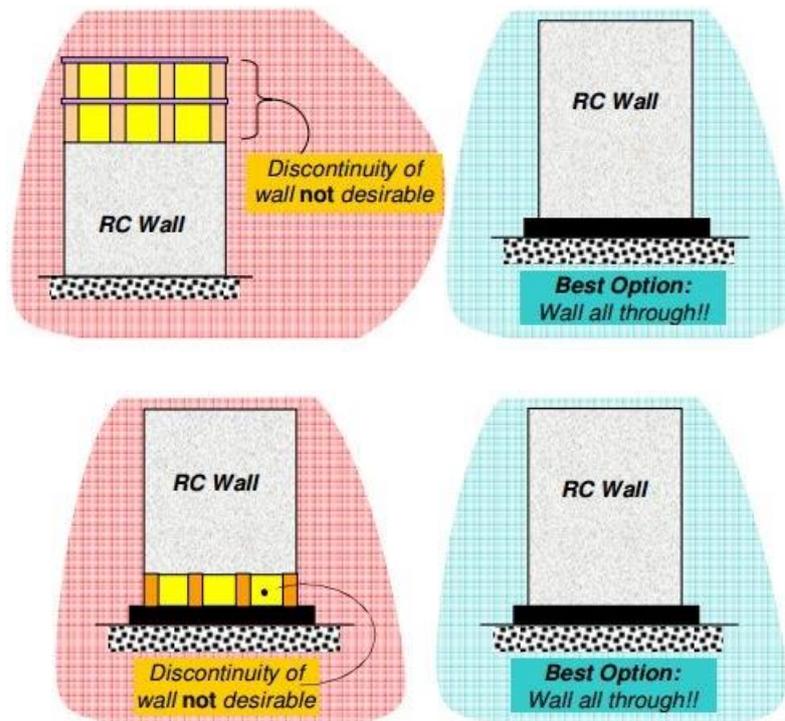
- Re-entrant corner. Cf §5 – Configuration for more details.
- Discontinuous walls: serious overstressing at the points of discontinuity due to the non-continuity of the load path through the walls from the roof to foundation.

Figure 7.7. Examples of discontinuous walls.

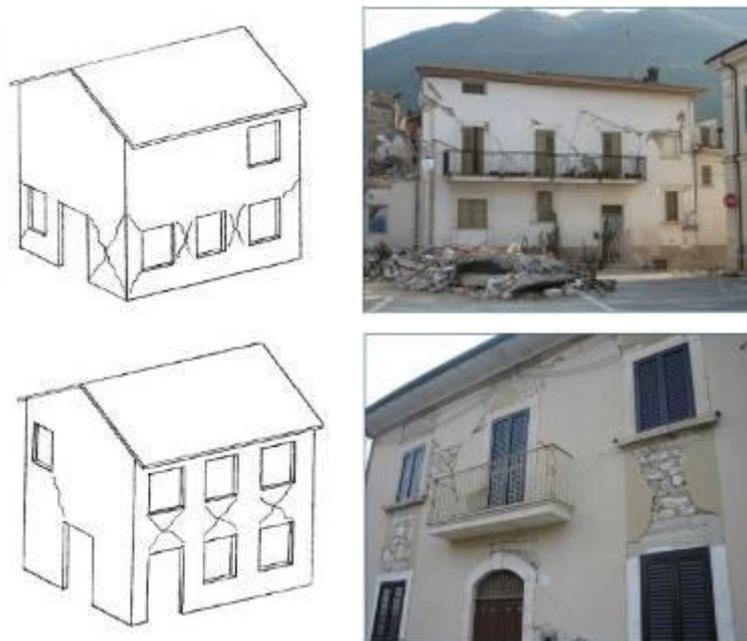
Figure 8.2. Examples of insufficient wall strength [6].

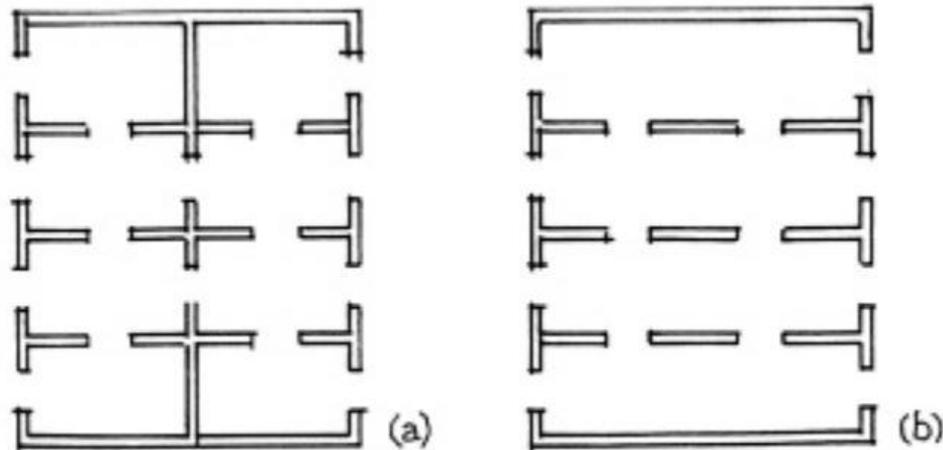
- Excessive torsion. Symmetrical buildings of relatively simple form usually perform better than complex shapes where walls are asymmetrically distributed on the plan [10].

Figure 8.3. Distribution of walls in plan (a) adequate – (b) not adequate.

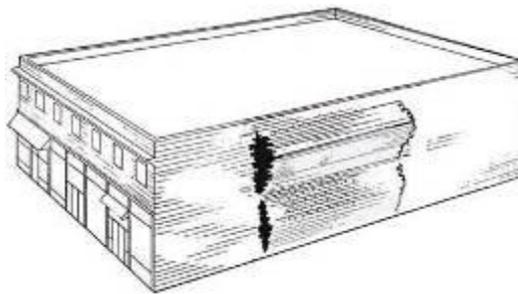
- Wall inadequate for out-of-plane bending. This kind of damage most often occurs due to the instability of structural elements. Once the walls have been anchored to the diaphragms, the unbraced length of these brittle walls may cause them to buckle out-of-plane during lateral loading. Additional bracing should be utilized between diaphragms to increase the out-of-plane strength of the URM wall assembly.

Figure 8.4. Out-of-plane failure [26].

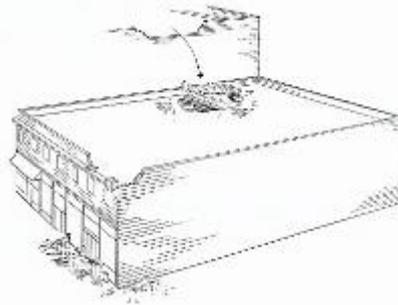
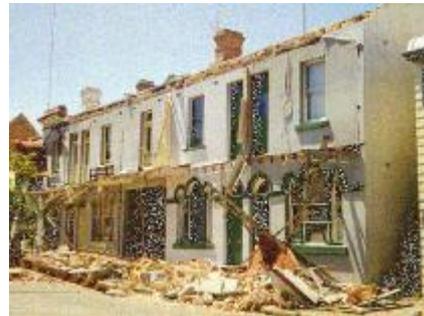
- Unbraced parapet. A lot of damage to URM buildings can be attributed to parapet failures when a seismic event occurs. The damage can occur not only to the building itself, but to nearby buildings, and poses a major risk to life safety. Bracing the parapets is a must when evaluating the needed retrofitting of a URM building.

Figure 8.5. Parapet failing [26].

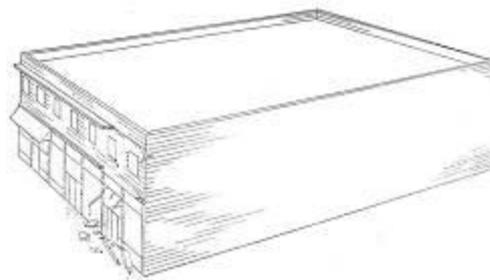
- Poorly anchored veneer or appendages. Non-structural elements can cause damages, it is important to perform better anchorage.

Figure 8.6. Veneer failing [26].

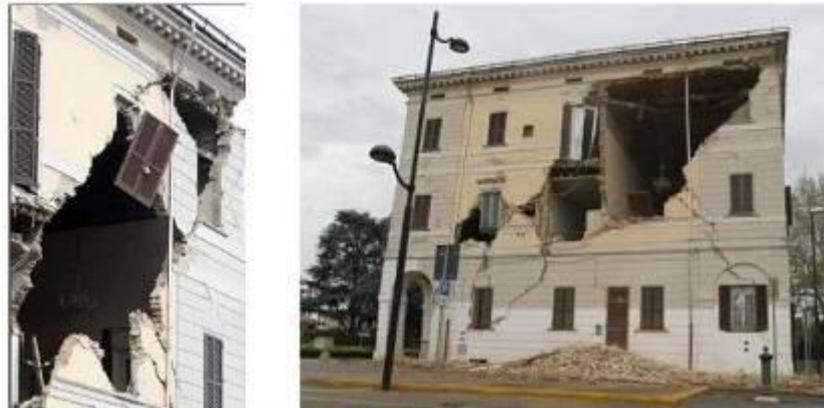
Figure 8.8. Inadequate chord capacity examples [6].

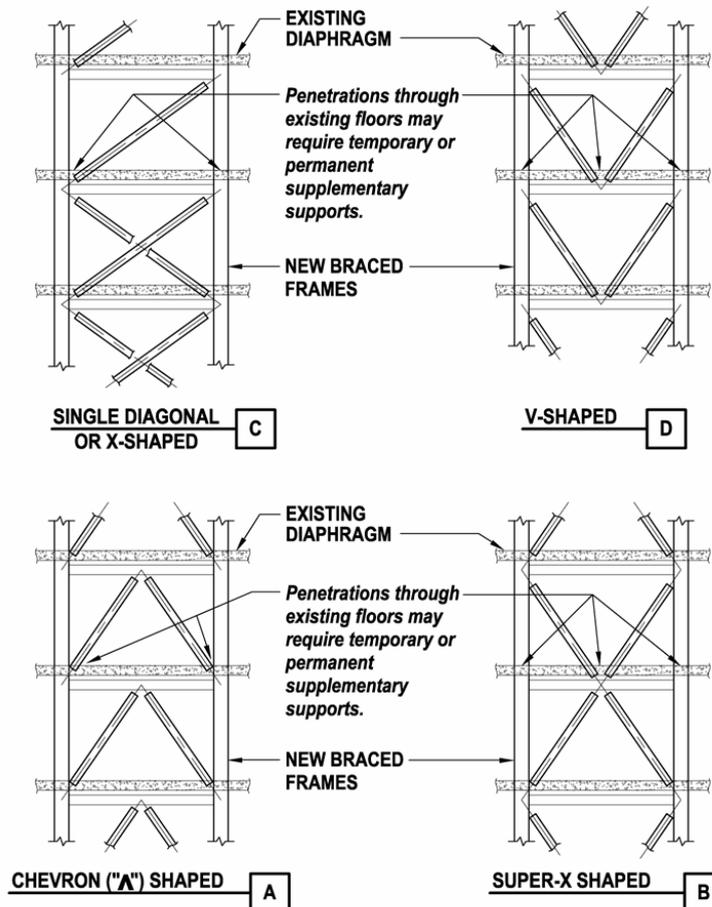
Figure 9.1. Typical braced frame configurations [1].

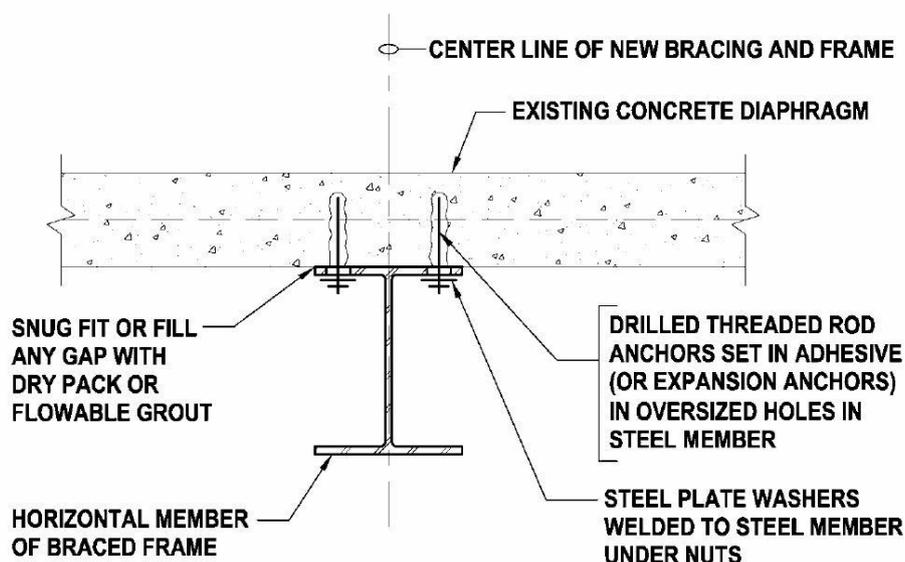
Figure 9.2. Typical connection to concrete diaphragm [1].

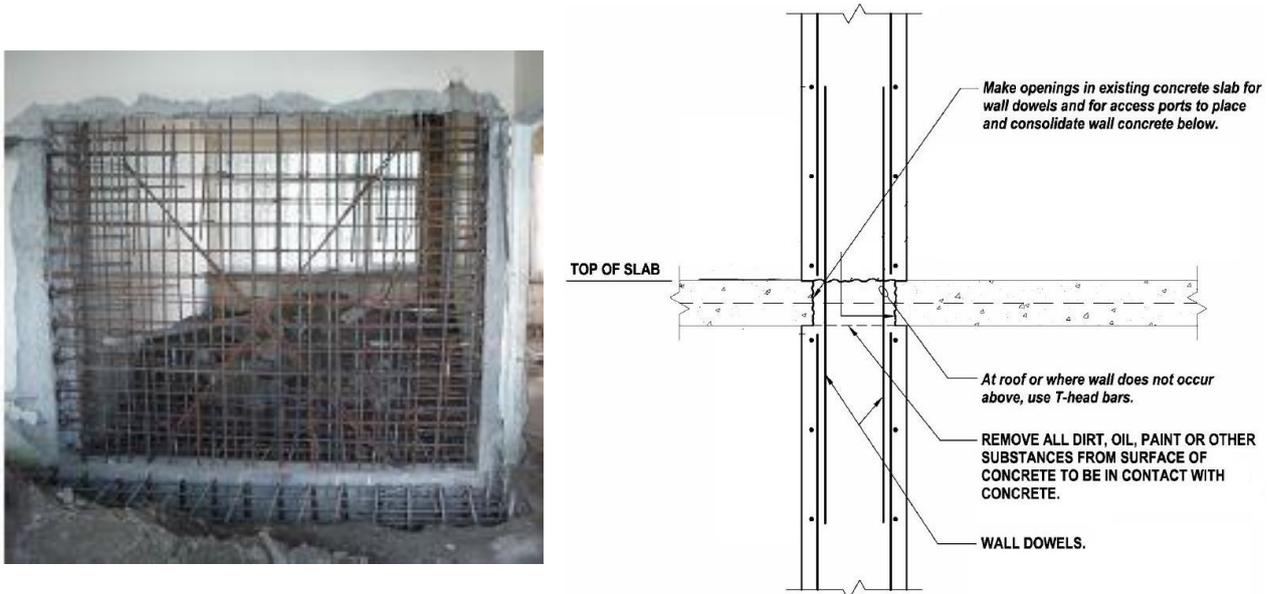
Figure 9.3. New concrete shear wall (left) and concrete wall connection to concrete slab (right).

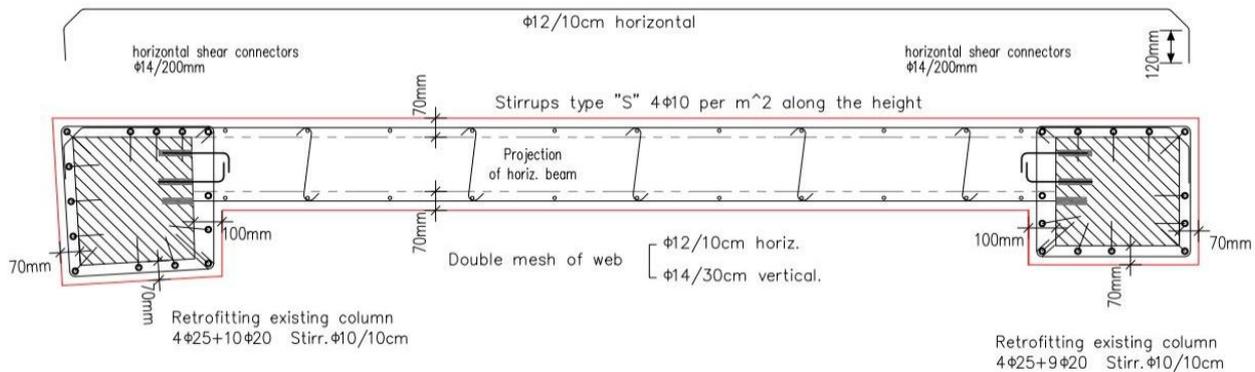
Figure 9.4. Sectional detailing example of new shear wall between existing column frame.

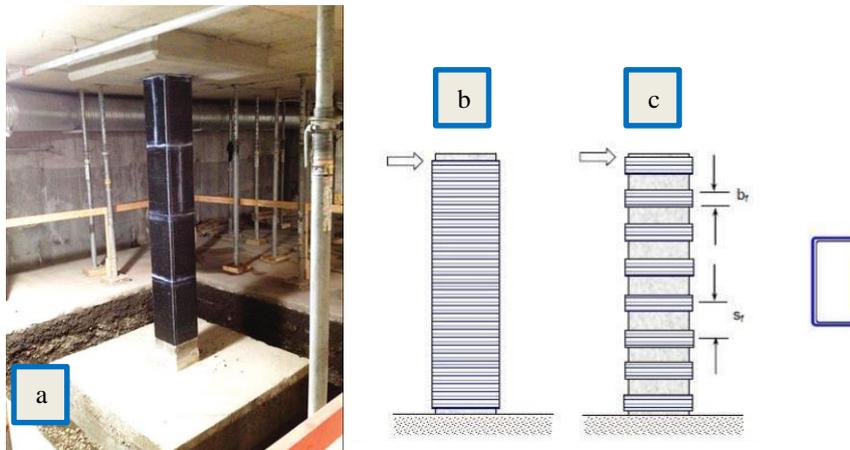
Figure 9.8. Shear strengthening of column with carbon - FRP composite materials: (a,b) sheets; (c) strips [20].

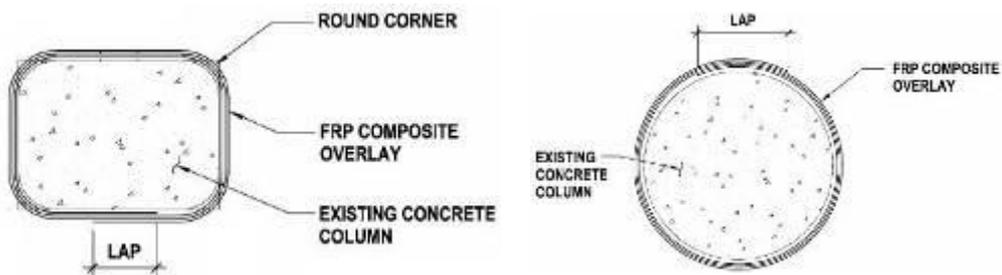
Figure 9.9. Rectangular and circular column jacketing with FRP composites [1].

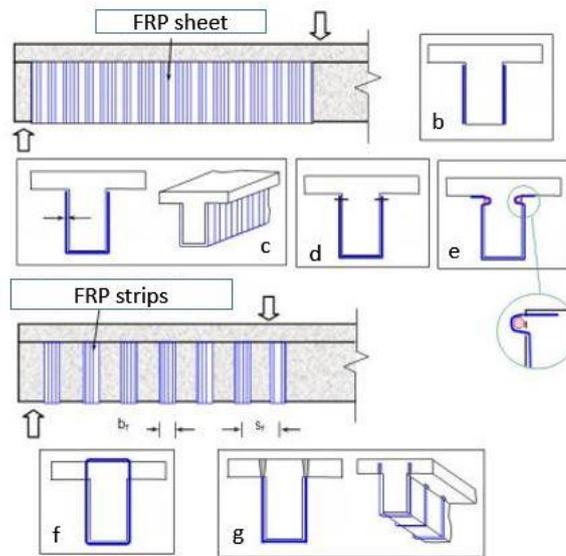
Figure 9.10. Representative configurations of FRP shear strengthening of RC beams [20].

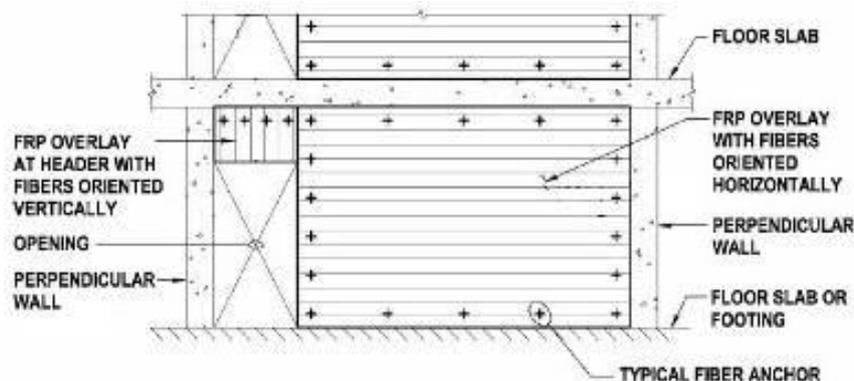
Figure 9.12. Strengthening of concrete shear walls using FRP composite [1].

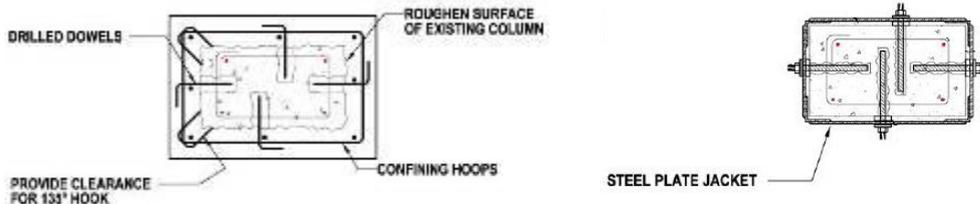
Figure 9.13. Concrete jacket (left) and steel jacket (right) [1].

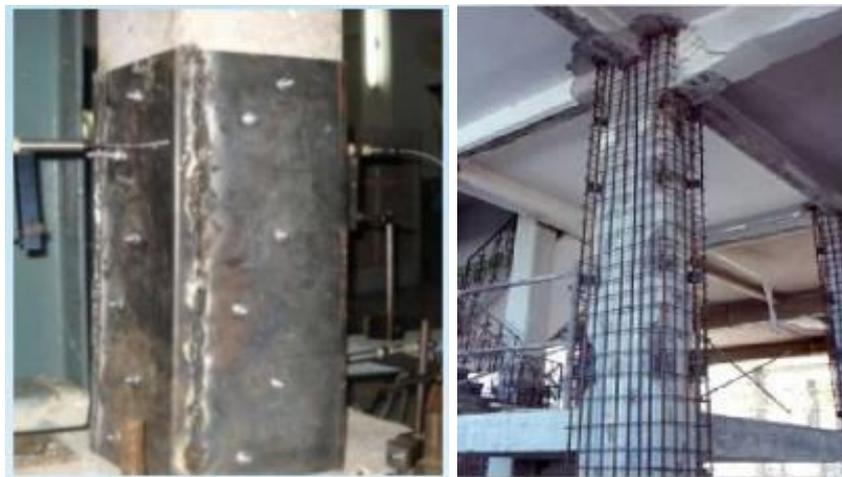
Figure 9.14. Column jacket examples: steel (left) and RC (right).

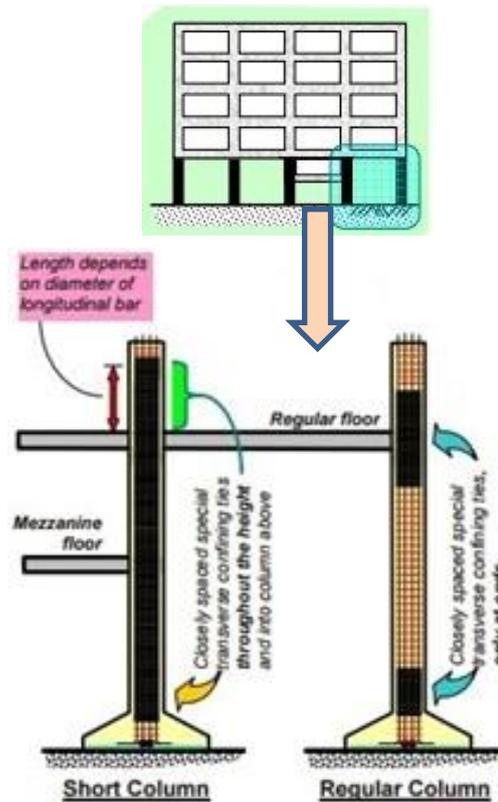
Figure 9.17. Detailing of sectional reinforcement of RC short columns [4].

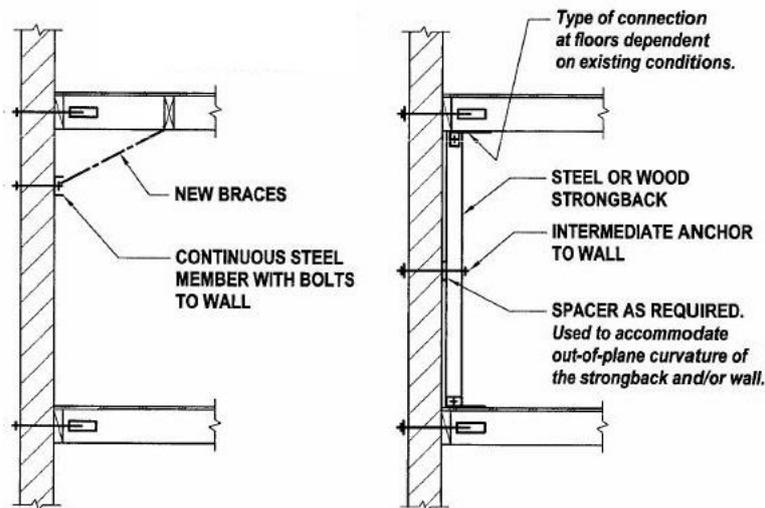
Figure 9.19. Wall bracing: diagonal (left) and vertical (right) [26].

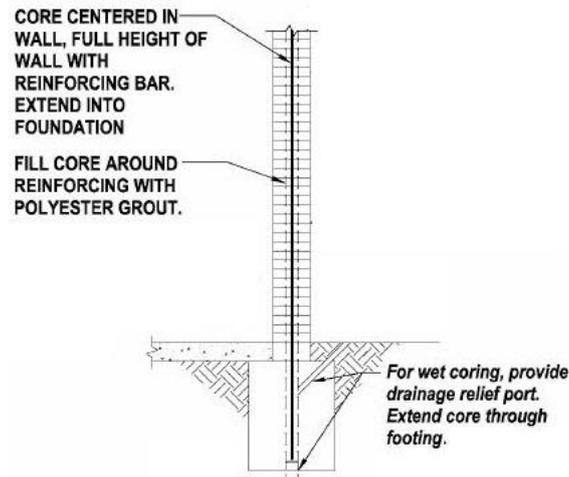
Figure 9.20. Reinforced Cores [1].

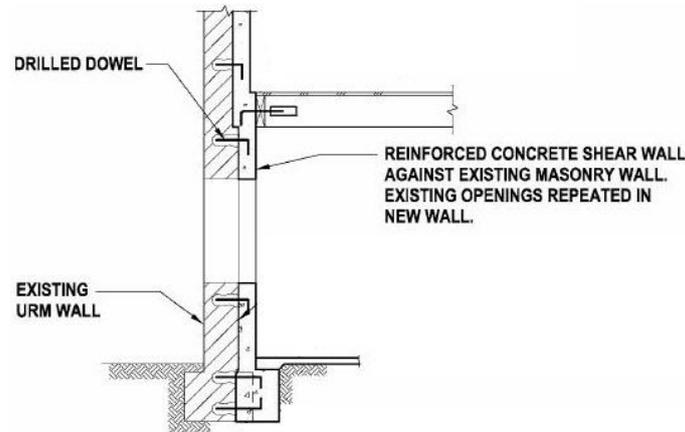
Figure 9.21. Concrete or shotcrete wall overlay [1].

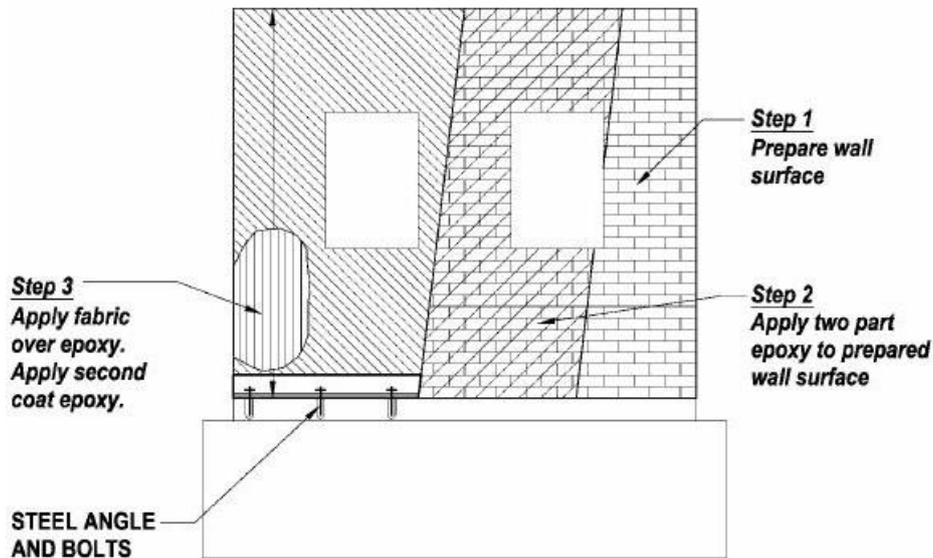
Figure 9.22. Fiber composite wall overlay on URM wall.

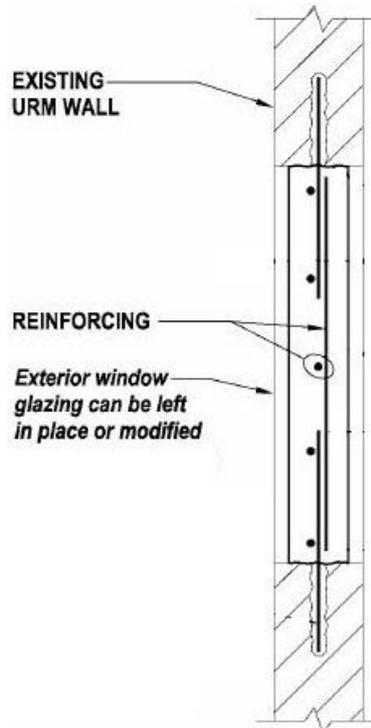
Figure 9.23. Infilling an opening in a URM wall [1].

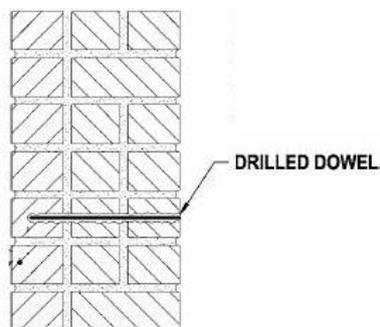
Figure 9.25. Veneer ties in brick masonry [1].
