**Support Action for Strengthening PAlestine  
capabilities for seismic Risk Mitigation  
SASPARM 2.0**

**Deliverable D.C.1**

**Report on the identification of retrofit measures**

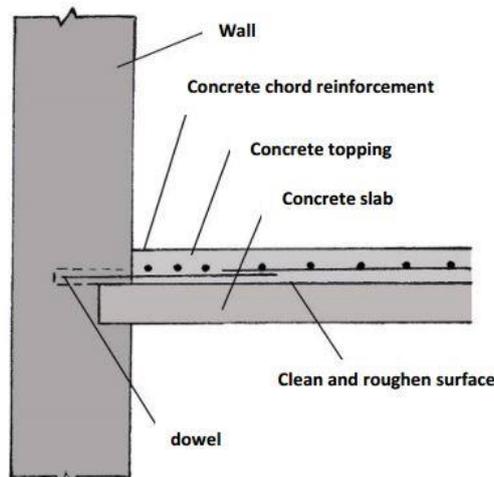
Figure 9.26. RC topping slab and chord on existing concrete diaphragm.

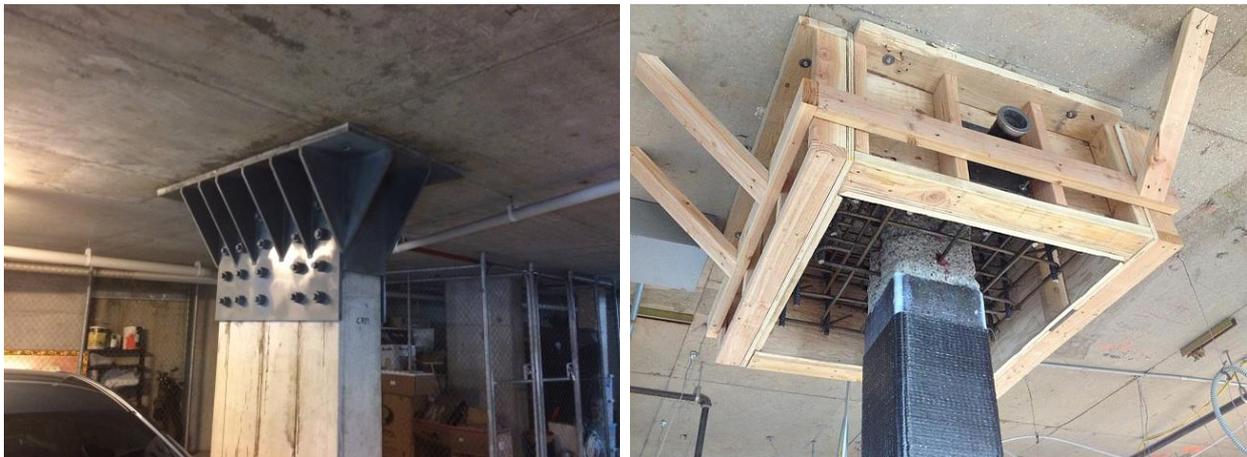
Figure 9.28. Retrofitting measures protecting slab from punching shear: steel (left) and RC (right) applications.

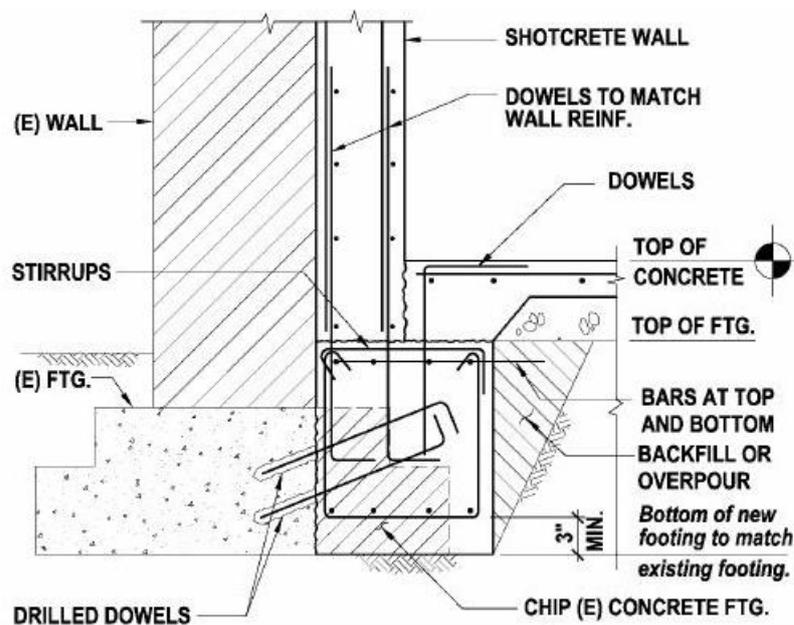
Figure 11.1. New concrete strip footing next to existing strip footing [1].

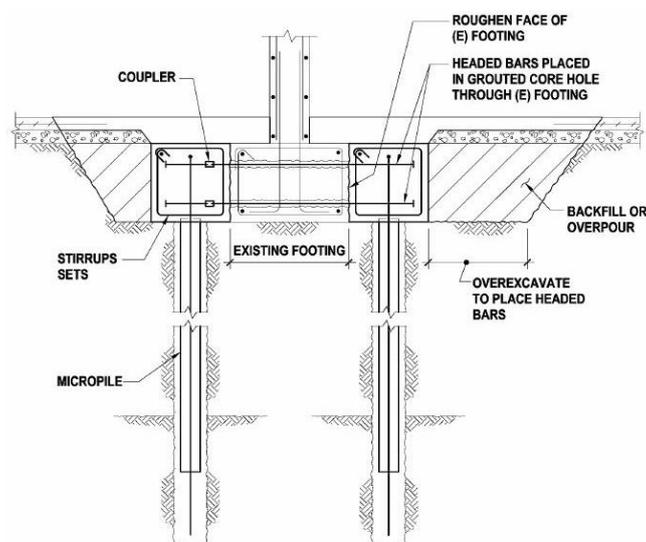
Figure 11.2. Section of micropile enhancement to existing strip footing [1].

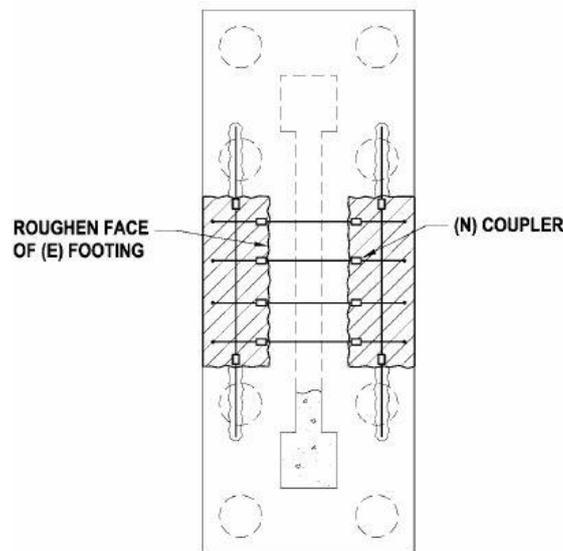
Figure 11.4. New mat foundation between existing drilled piers (plan) [1].

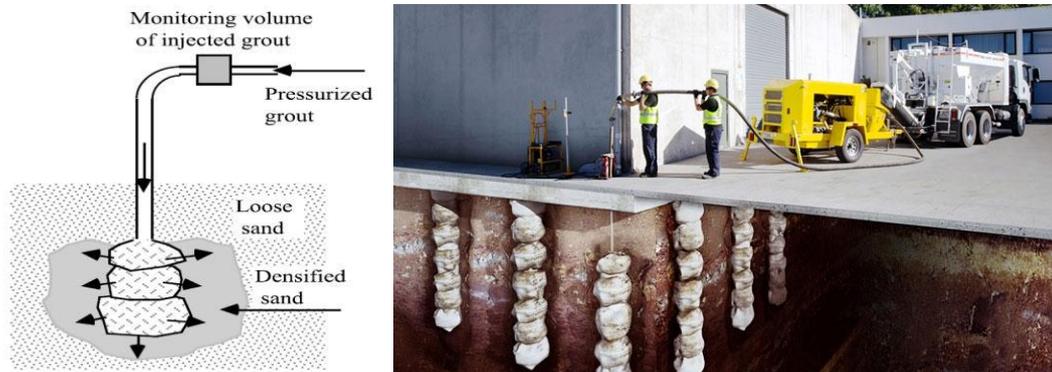
Figure 11.5. Compaction grouting example.

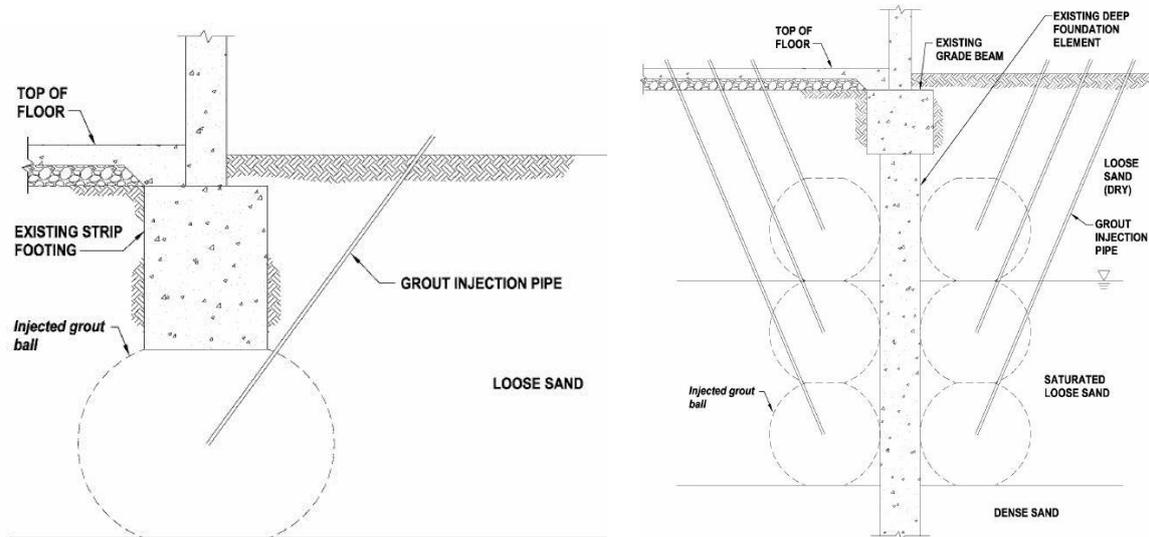
Figure 11.6. Permeation grouting under existing shallow foundation (left) and deep foundation (right) [1].

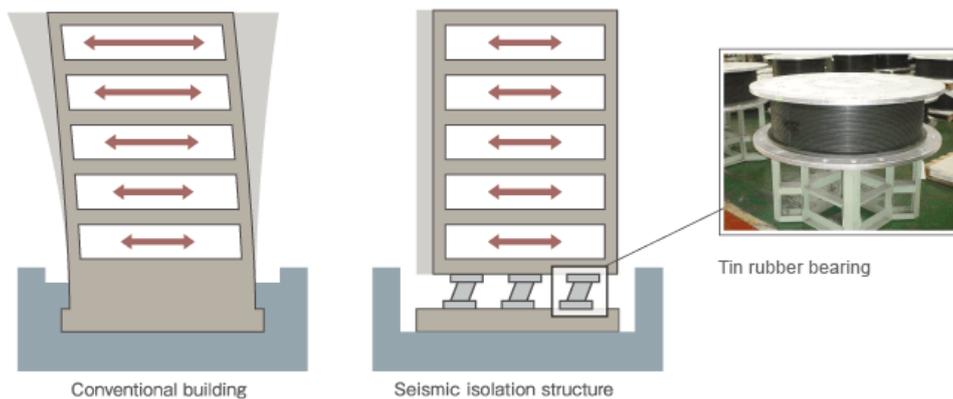
Figure 12.1. Seismic isolation scheme.

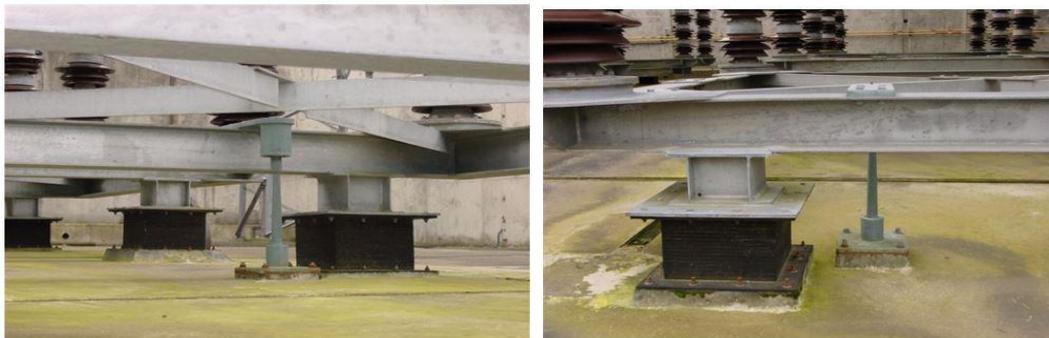
Figure 12.2. Seismic isolation example.

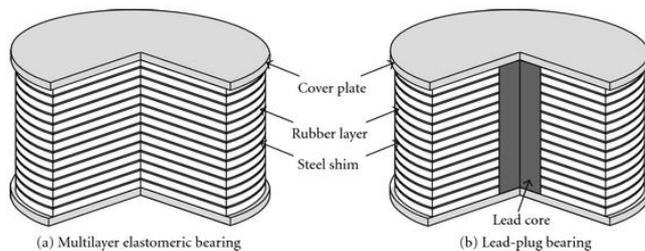
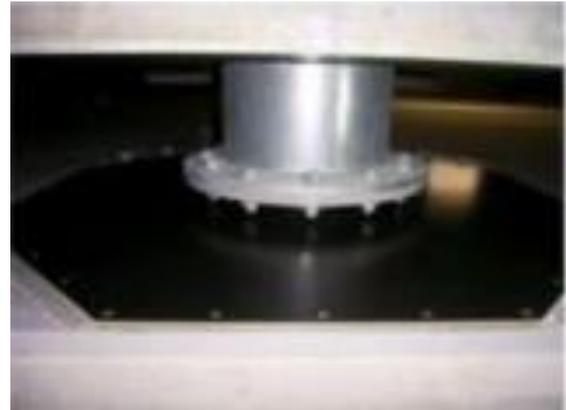
Figure 12.3. Elastomeric isolator (left) and slider isolator (right).

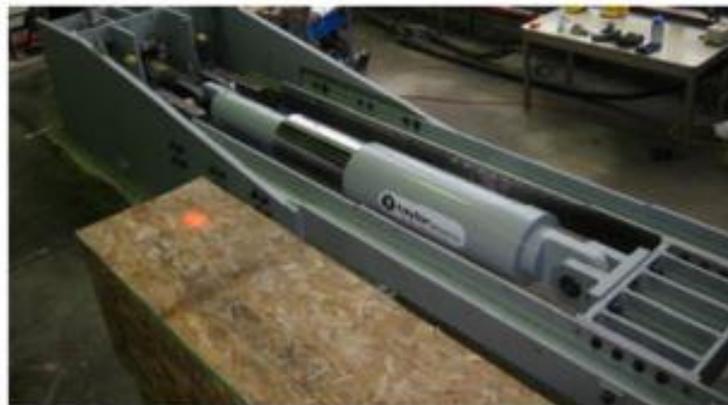
Figure 12.5. Fluid damper example (Courtesy of Cameron Black, SIE Inc).

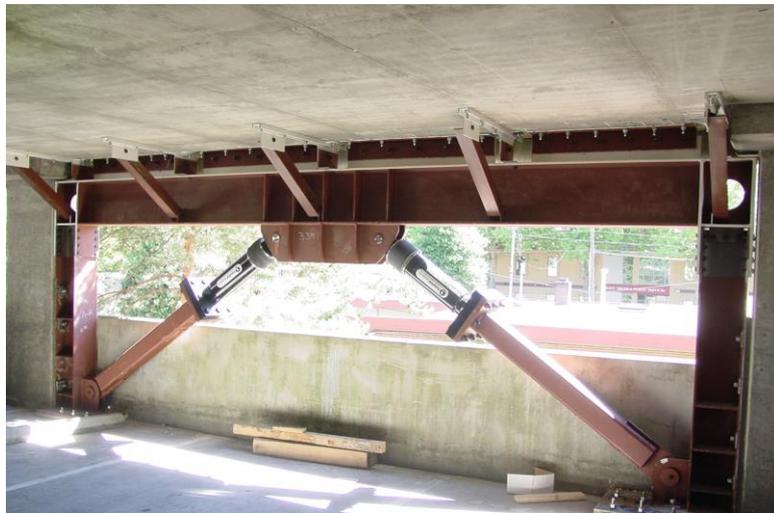
Figure 12.6. Damper example.
